Statewide Survey of Historic Resources
State Historic Preservation Office
South Carolina Department of Archives and History
8301 Parklane Rd.
Columbia, SC 29223-4905 (803) 896-6100

Intensive Documentation Form

Historic Name: United States Post Office

Address/Location: 309 N Main St

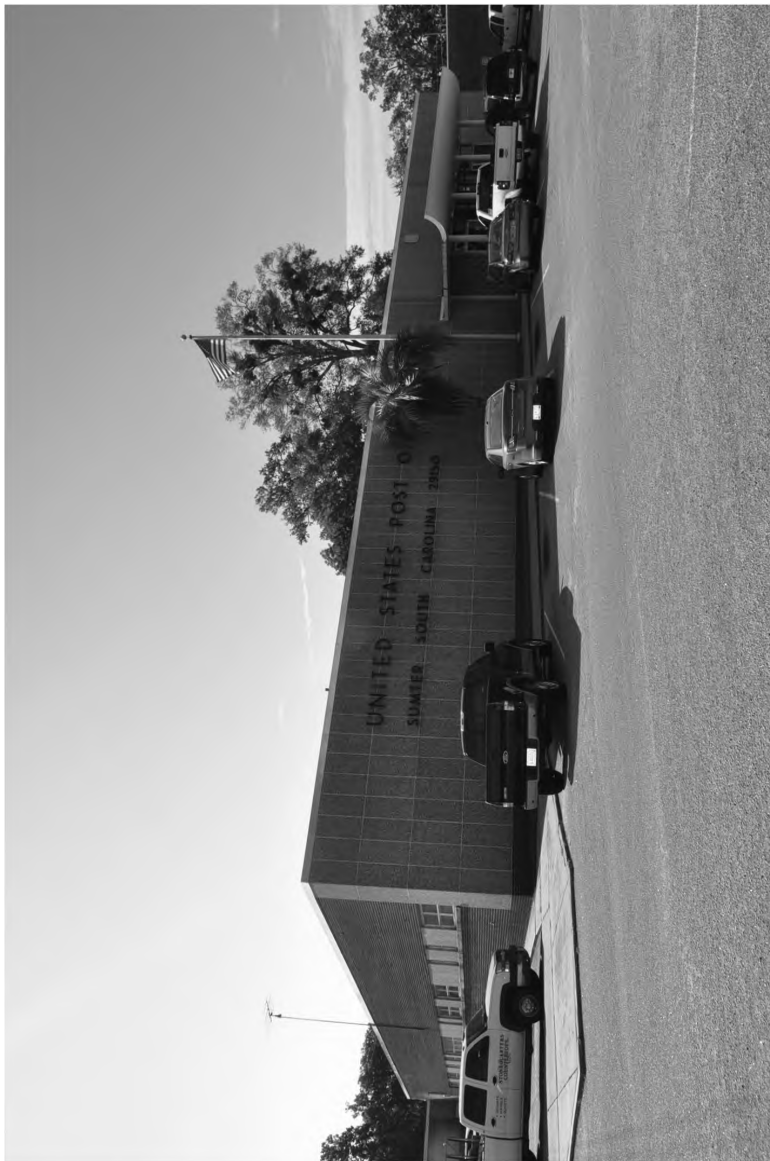
Significant Architectural Features: Pebble dash stucco on facade, asymmetrical with concrete roofed porch (flat curving upwards at edge) with round supports over vestibule with two sets of double metal and glass doors with transom, plate glass windows in space between doors, CMU screen on side panels of vestibule, bands of aluminum frame windows on side elevations, left side with pebble dash in band between windows
